Was Kingswear's church tower also built for defence?

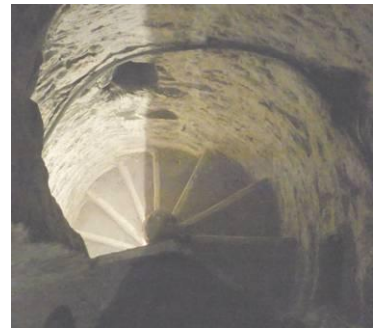
Figure 1 Stairs inside the tower

The Kingswear tower has a circular stone staircase to the first floor, taking two full turns to get to the higher level. Earlier accounts report a fireplace on the first floor with a flue to the roof. The flue still exists and stretches from the ground floor to the top of the tower, figure 2. It is possible that the flue and the fireplace are later additions as, unlike the staircase, the flue is not integral with the wall.

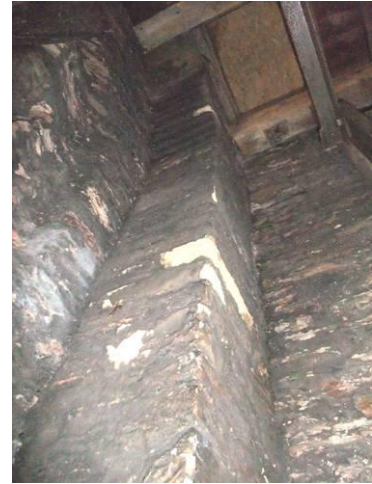
Figure 2 Flue from the second floor to the roof

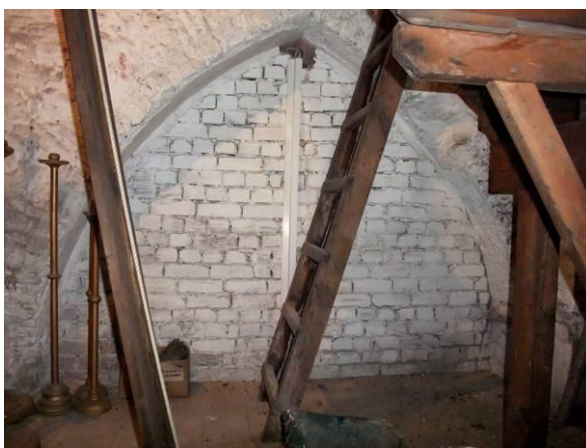
Figure 3 Arch from inside tower

Where the fireplace was is not clear. It is assumed that the wide arch in the south wall and next to the flue is original and dates from when the tower was built. The arch, now bricked up – figures 3 & 4, takes up almost the full width of the inside of the tower and could have provided access to the bell rope. The arch, when it was open, would have exposed the present first floor which is about two-thirds up the arch. Perhaps this is not the position of the

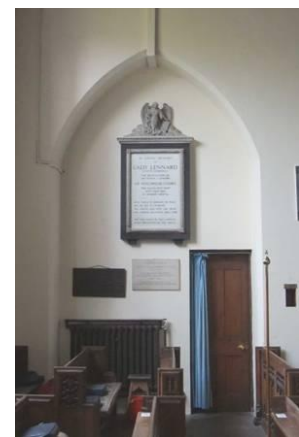
Figure 4 Arch from outside tower

A plan of the church, figure 5, shows that the arch subsequently housed an organ. The plan shows steps up from the ground level inside the tower leading to the back of the organ and partitioned off from the room which is now used as the vestry. The door shown in figure 4 is a recent addition and the north entrance to the church was outside the tower off the picture to the right, as in Figure 5.

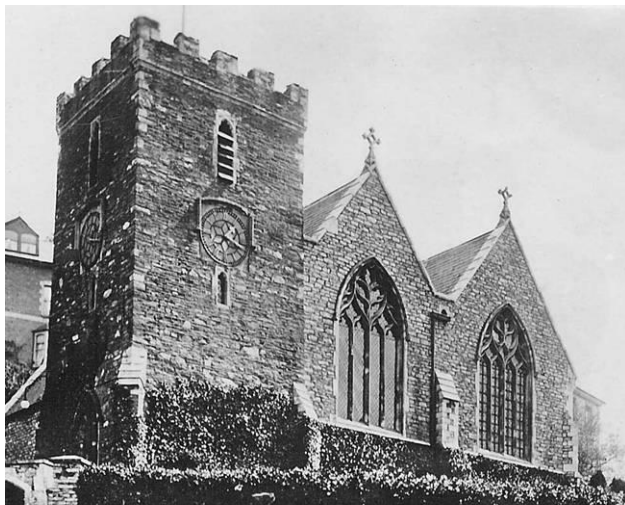
Figure 6 Church tower in 1905 before the addition of a new vestry

Cox states that another feature of a tower used for defence is “*lower windows far from the ground and so narrow as to be little more than loopholes*”. Kingswear has two, see figure 6, which face to the west (river) and to north (up river). No doubt these were for letting a little light into the first floor – there would have been no glass – but would also be difficult for anyone on the ground to project a missile into the tower.
